City of Gahanna

Facility Assessments

March 05, 2018

OHM Advisors

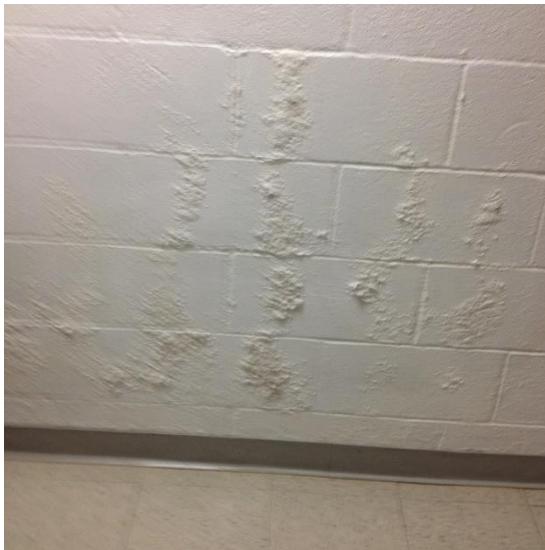
Evidence of moisture infiltration in basement walls

| STRUCTURAL | Rating | A | Priority | 2 | |
|---|---|---|---|---|---|
| Foundation Walls | Rating | B | Priority | 2 | Moisture Infiltration through walls |

| INTERIOR SPACES | Rating | A | Priority | 1 | |
|---|---|---|---|---|--|
| Walls | Rating | A | Priority | 3 | Basement water infiltration |

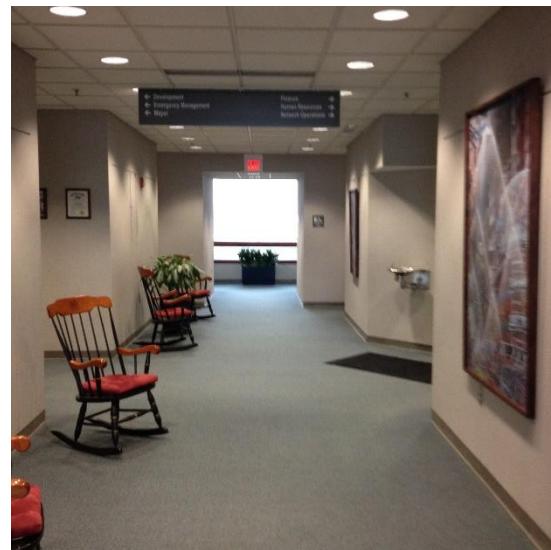
Dated finishes and lighting, and wasted space

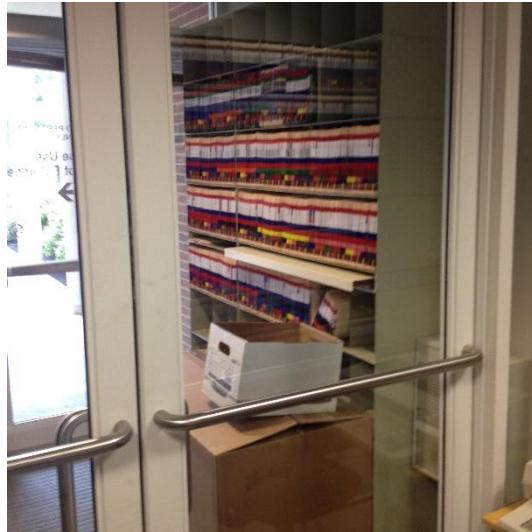
Storage in exit vestibule

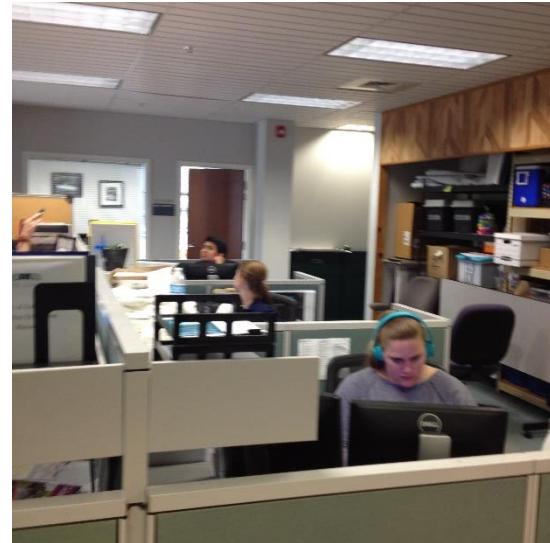
Cramped inefficient space utilization

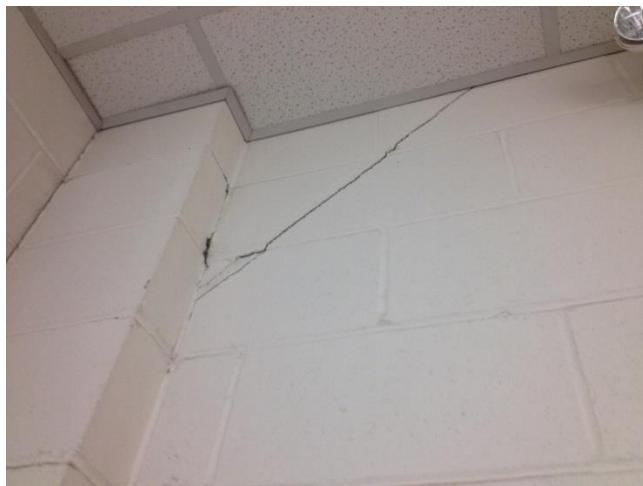
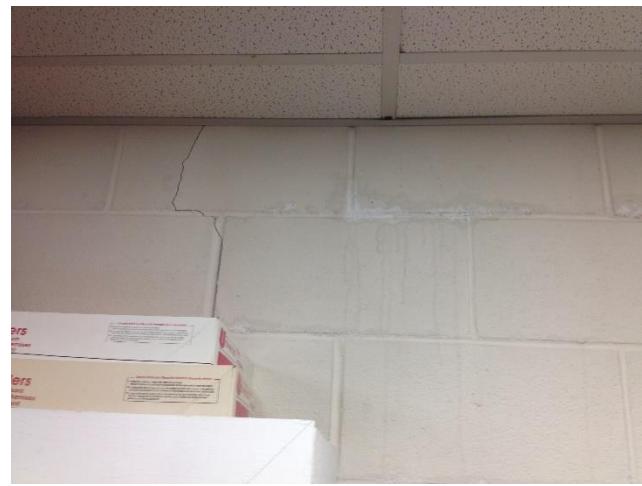
This shared facility is in generally good condition. There is a concern with some cracks that are visible in the south wall and stairwell and at the east side of the break room. The south wall also shows signs of water damage due to a current or former parapet or roof leak. Due to structural movement, some exterior doors do not operate properly and are racked or binding. The hardware configuration on the doors does not meet ADA standards. Refer to Program and Needs Assessment report for other functional concerns.

Cracks in wall at break room and stairwell.

| EXTERIOR ENVELOPE | | Rating | B | Priority | 3 | |
|---|---|---|---|---|---|--|
| Cracks | | No | Yes | Priority | 3 | South wall and stairwell wall need to be reviewed. Cracks visible. |

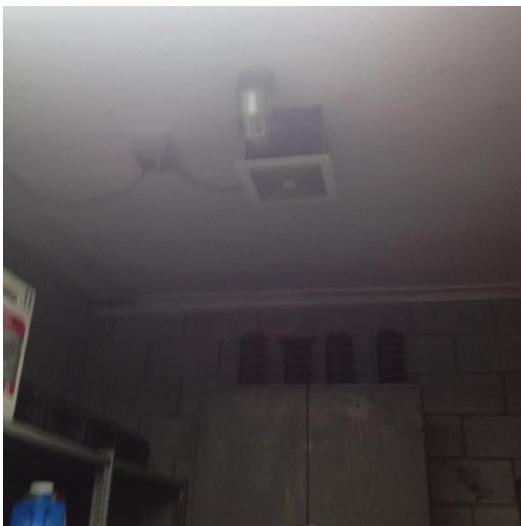
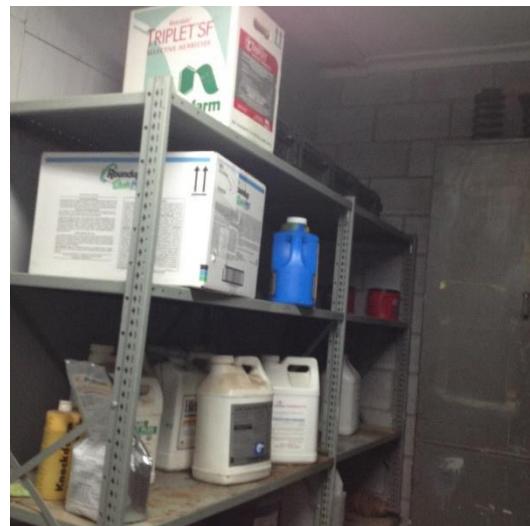
Chemical storage and bath ventilation to remove fumes.

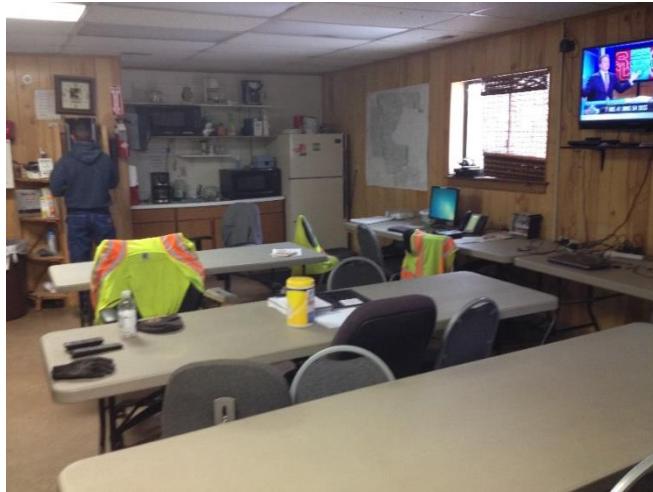
Break Room/Training Room

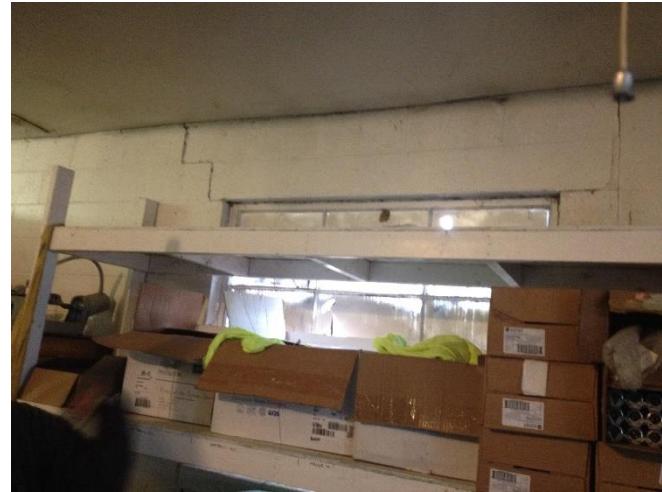
Structurally, the buildings are utilitarian, and in fair condition. There are small cracks and routine maintenance items such as missing sealant that were noted. The home-made nature of the office and break room improvements causes the most concern since it is not clear whether the materials are properly constructed and installed to meet building code requirements regarding fire resistance and proper fire separation between maintenance / shop functions and administrative space. Office doors and corridors do not appear to carry proper flame spread and fire ratings.

Structural Cracks to be addressed

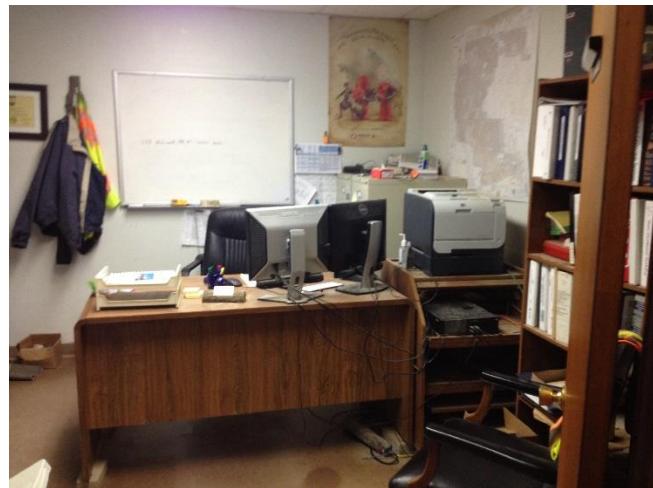
Typical Office

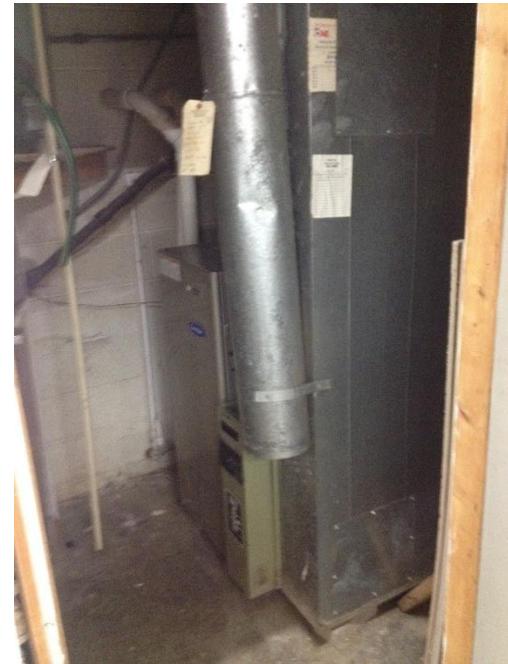
As a shop and maintenance facility, the unit heaters are adequate. Due to the office and break room added, a makeshift furnace has been installed. Proper code compliant commercial quality systems and materials installed with proper fire separations should be considered if long term use is anticipated.

Makeshift furnace

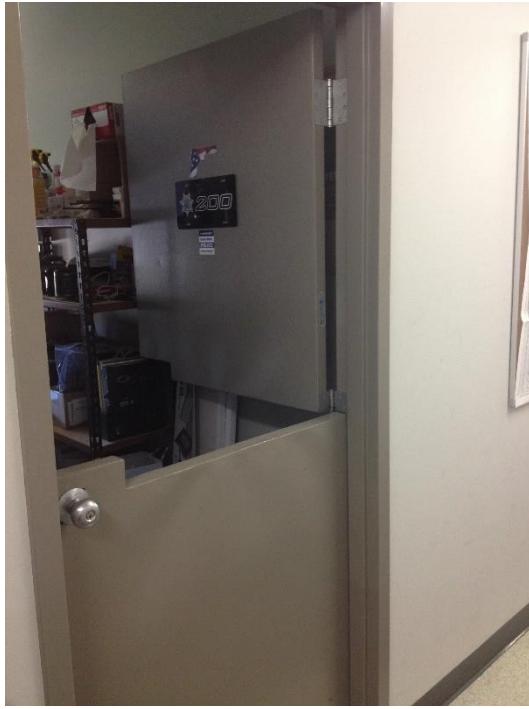
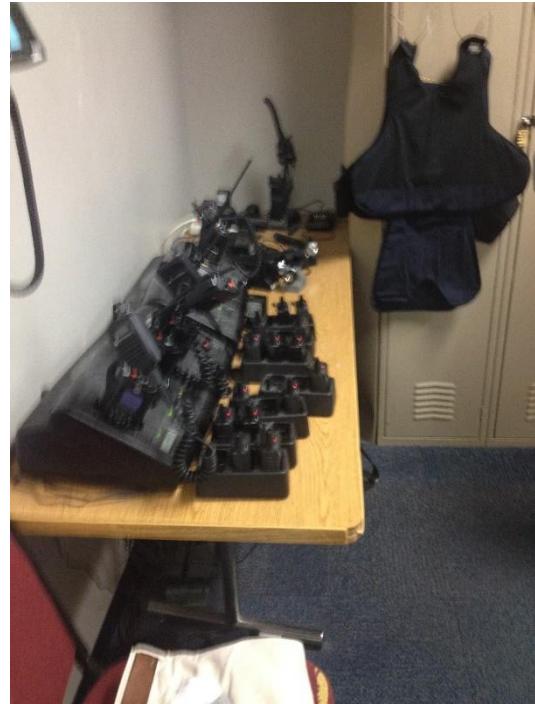
Fire door must be on closers or hold-opens to release in the event of a fire. Charging stations for radios and flashlights in makeshift location.

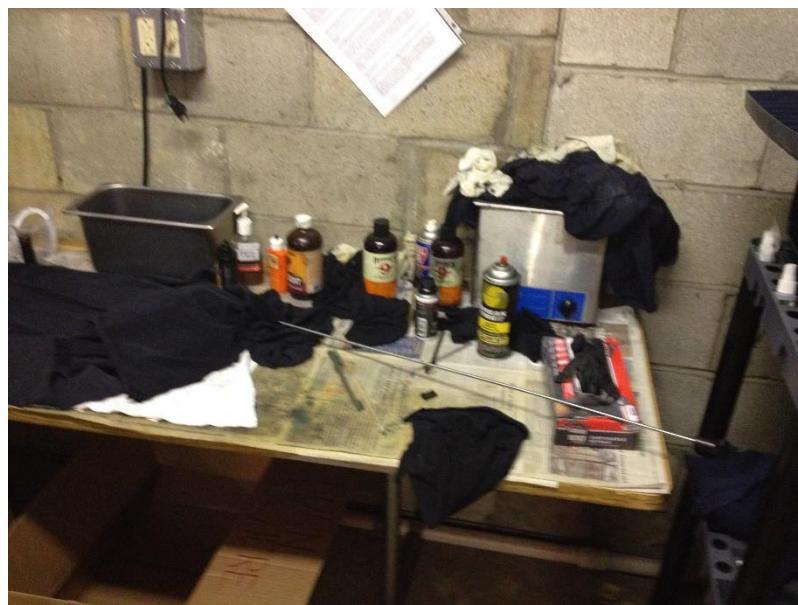
"Gunsmith" workbench without proper ventilation

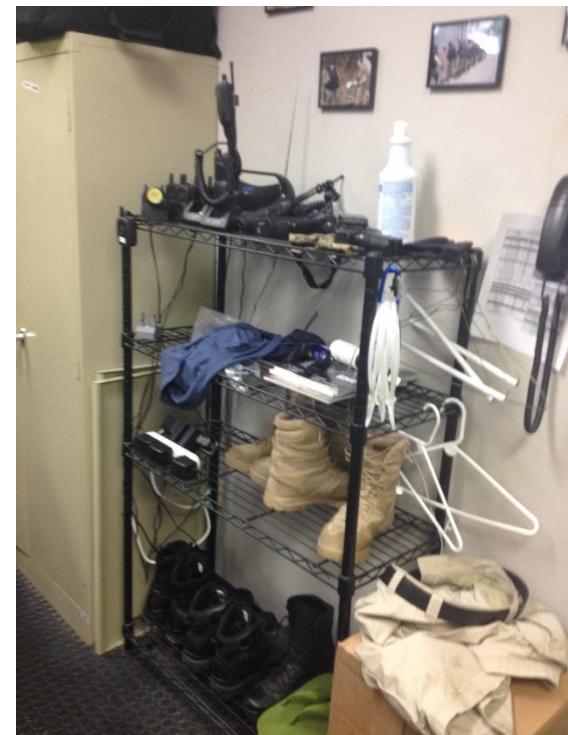
SWAT Team storage

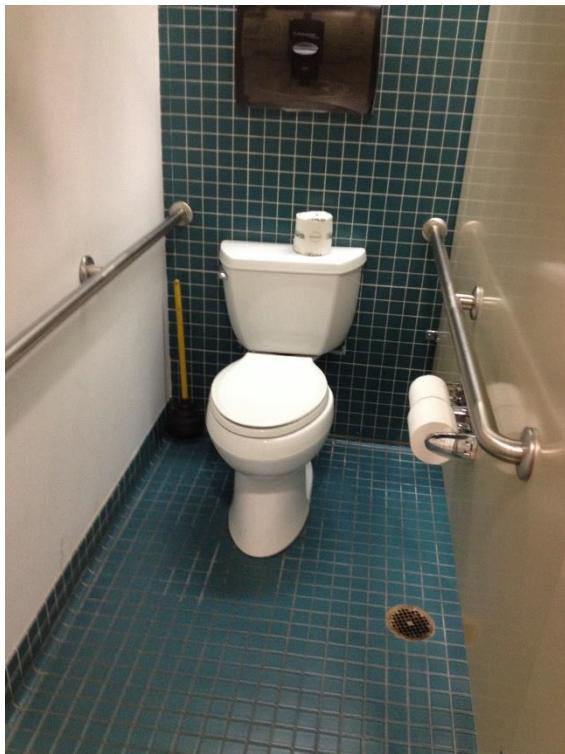
Toilet stall does not comply with current ADA

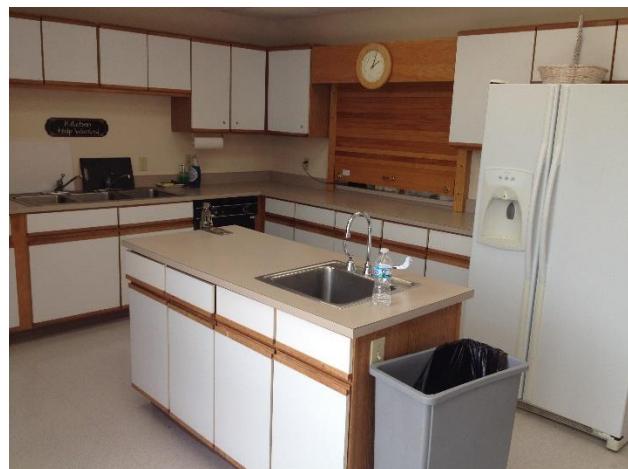
Kitchen in Senior Center is compliant with standards
